**TRANSPORTATION SCIENCES CENTER
ACCIDENT RESEARCH GROUP**

CALSPAN CASE NO. CA94-31

**VEHICLE #1 - 1992 TOYOTA CAMRY LE
DRIVER SIDE AIR BAG
DRIVER FATALITY**

ON-SITE INVESTIGATION

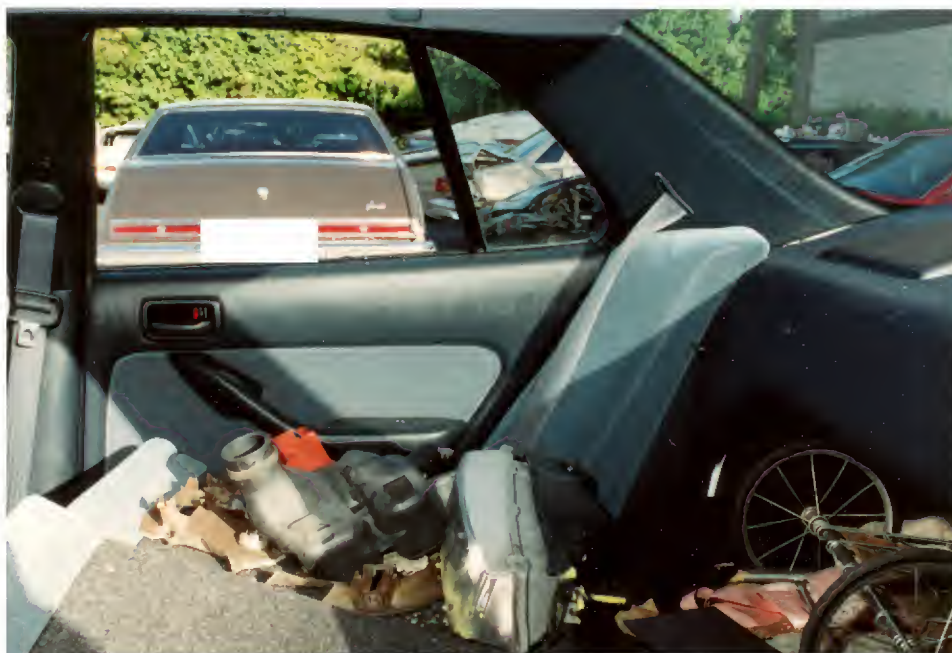
64. Lateral view of the rear seat area taken from the left side.

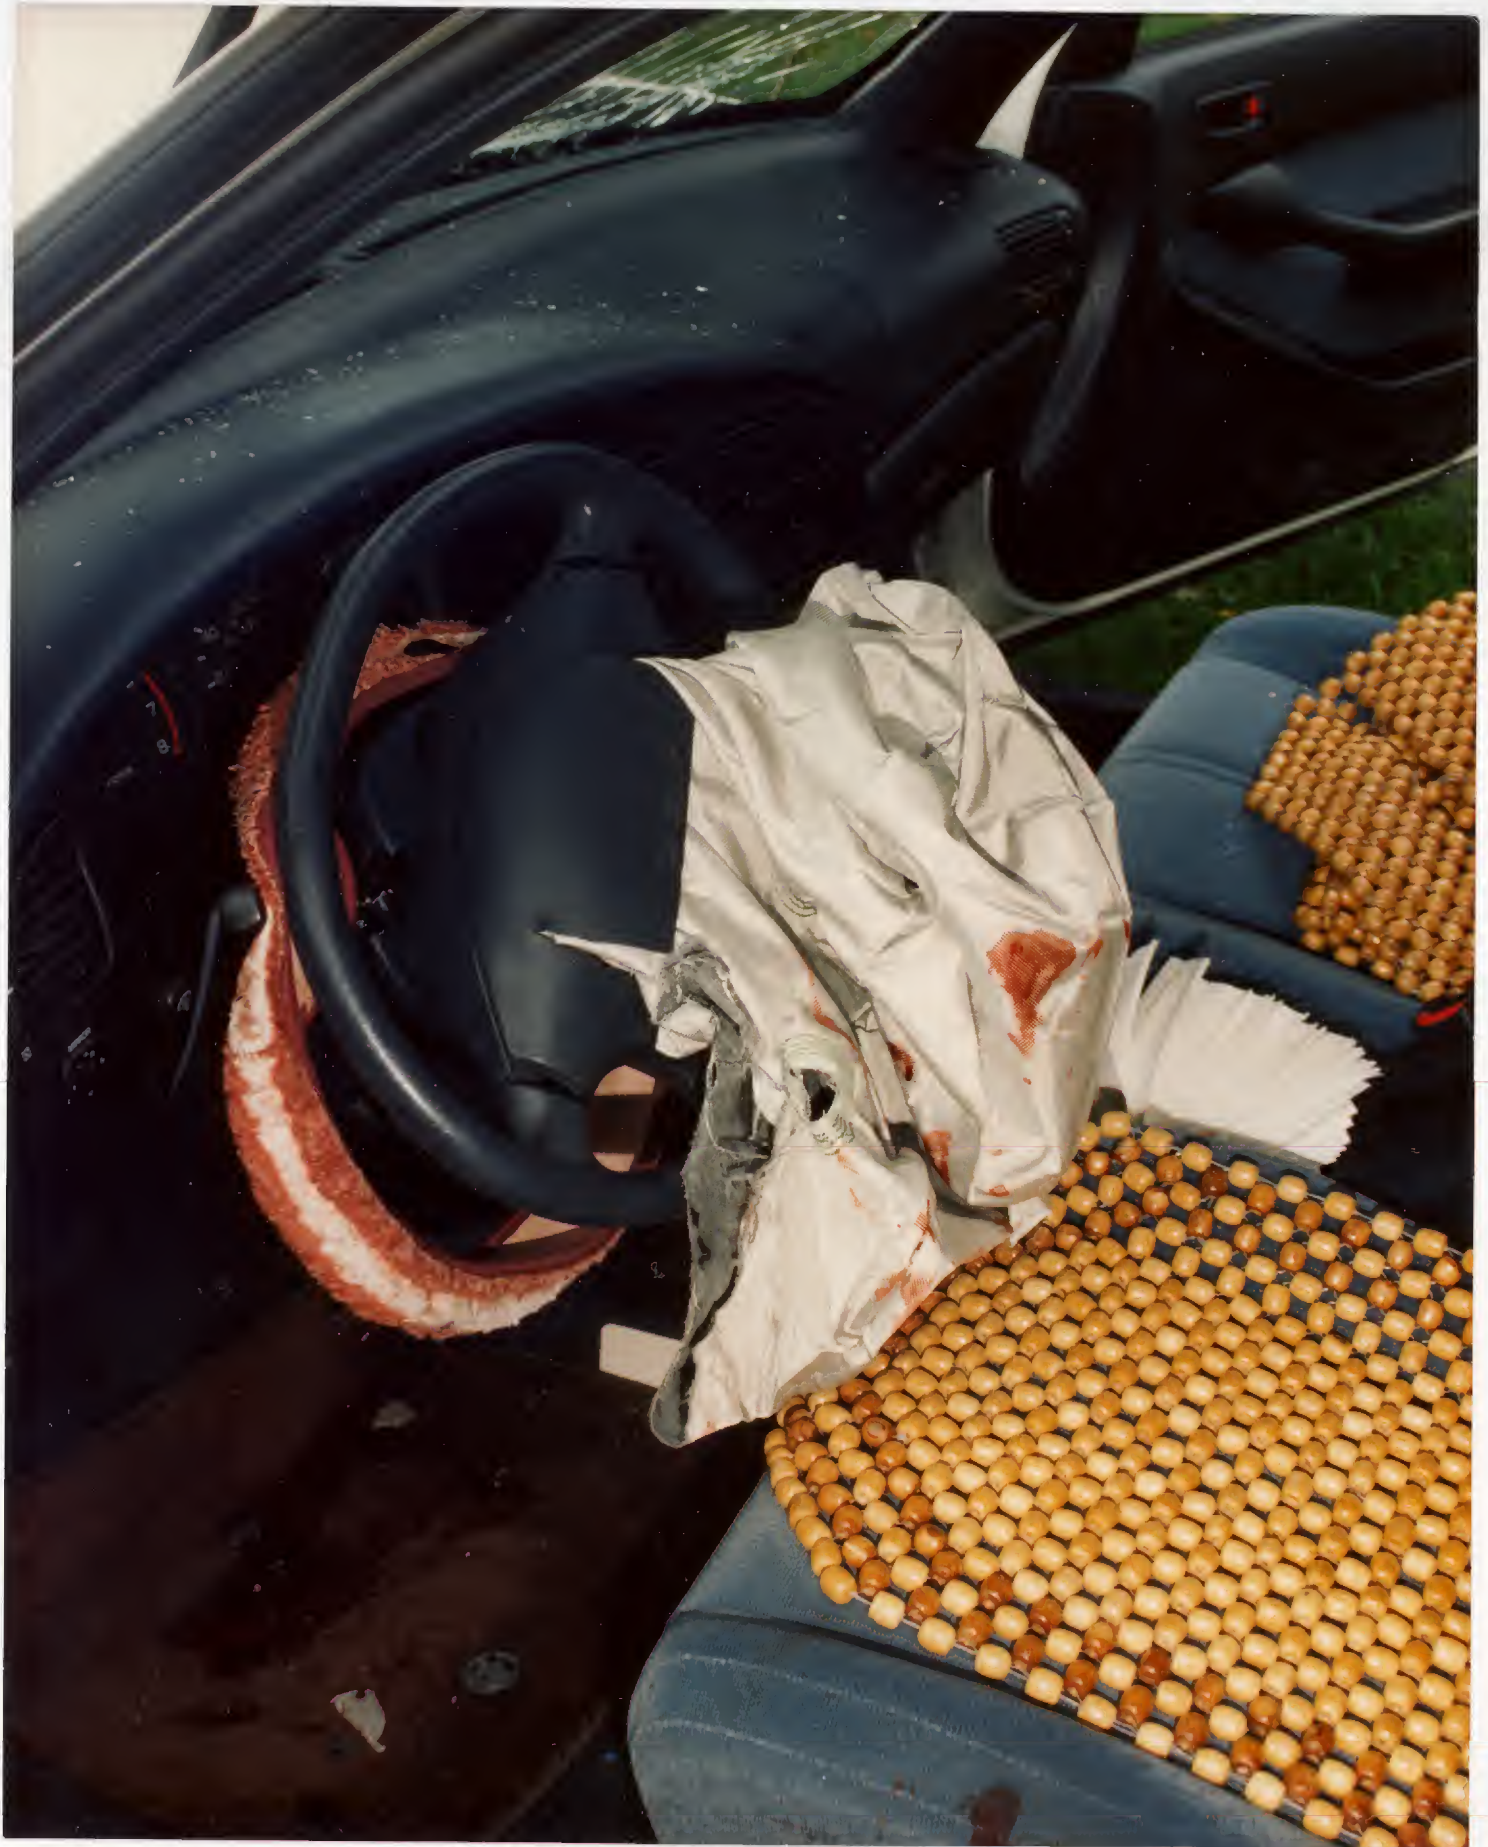
69. On-scene view of the driver side air bag.
